WL-TR-92-3069

ADD-ON DAMPING TREATMENT FOR THE F-15 UPPER-OUTER WING SKIN

JULY 1992

FINAL TECHNICAL REPORT FOR PERIOD 1 JANUARY 1989 TO 28 FEBRUARY 1991

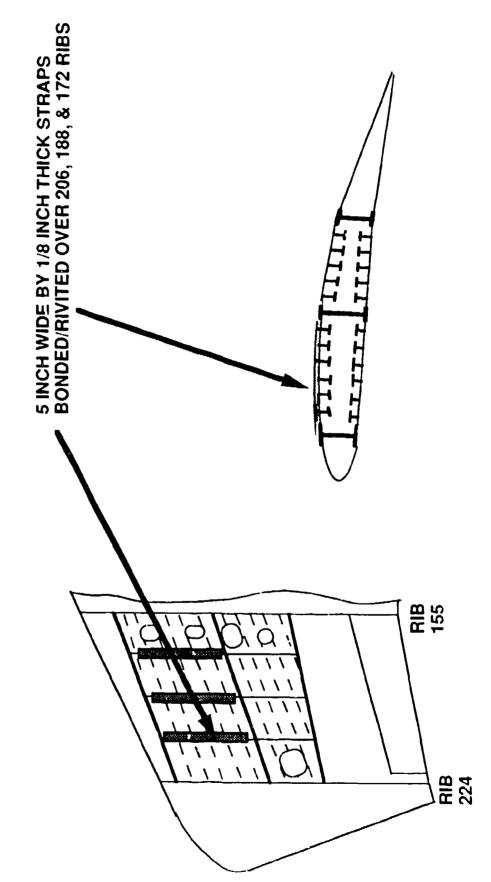
Figure 5. Detail of External Straps

FIELD INSTALLED STAINLESS STEEL STRAPS TO EXTEND SERVICE LIFE

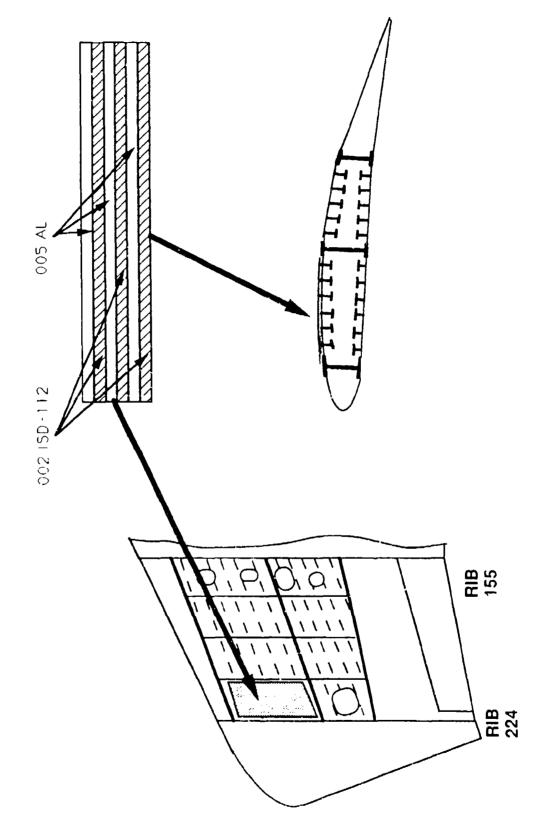
Bigure 37. "1980 Damping Treatment"

A previous attempt by MCAIR to correct the UOWS fatigue cracking included the application of a multiple constrained-layer damping treatment referred to as the "1980 Damping Treatment." The treatment was applied externally over bay L1 of the skin (see Figure 9) because at the time, the fatigue cracks were considered to occur only in this outer spar-rib bay. It consisted of three constrained layers, each containing a 0.002 inch layer of ISD-112 VEM and a 0.005 inch layer of aluminum. Figure 37 illustrates the "1980 Damping Treatment" which for this investigation was denoted Test Configuration 1 (TC1). Figure 38 is a photo of the "1980 Damping Treatment" installed on an F-15 wing. Note the ramp of sealant around the circumference of the treatment to protect the edge from the air flow and prevent moisture from getting under the treatment. After paint is applied to the top constraining layer and the sealant, the damping treatment is barely noticeable. The "1980 Damping Treatment" was installed and flown on numerous operational F-15 aircraft but it proved to be unsuccessful in eliminating the UOWS fatigue cracks.

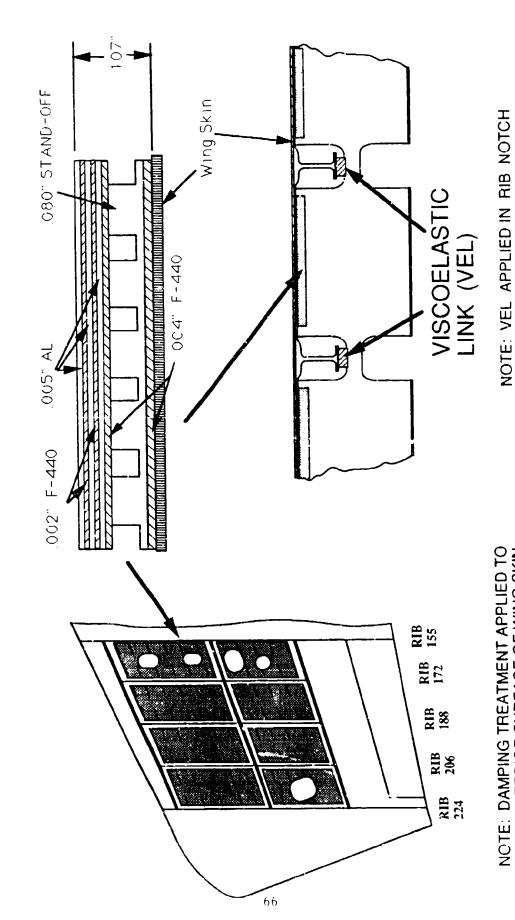
Figure 41. Internal Damping Freatment Design

NOTE: DAMPING TREATMENT APPLIED TO INTERIOR SURFACE OF WING SKIN BETWEEN STIFFENERS.

The recommended internal treatment design is summarized in Figure 41. Starting at the wing skin, there was a 0.004 inch layer of pressure sensitive adhesive (PSA) which performed as a VEM. Next there was an 0.080 inch stand-off layer of syntactic foam configured to maintain high shear stiffness and low flexural stiffness. This was achieved by cutting a checker board pattern into the syntactic foam. Finally, three constrained layers of damping material were placed on top of the stand-off layer. The first constrained layer (from the bottom) consisted of 0.004 inch of VEM constrained by 0.005 inch of aluminum. The other two constrained layers each consisted of 0.002 inch of VEM constrained by 0.005 inch of aluminum. For all layers the Hueston Industries F-440 VEM was used. The internal damping treatment was applied in the chemically-milled pockets between the integral stiffeners for all 8 spar-rib bays shown in Figure 9. Additionally, there were viscoelastic links (VELs) placed between the caps of the integral stiffeners and the notches in the ribs. The VELs were located in all rib notch locations. The VEL material was slightly tacky at room temperature. A VEL thickness of 0.50 inch was used to provide an interference fit. The purpose of the VEL was to provide a link (having both stiffness and damping) from the stiffener cap to ground (rib notch), thereby reducing stiffener rotation. Figure 42 shows the stand-off damping treatment applied to the internal surface of the wing skin. Figures 43 and 44 shows the VELs located in the rib notches.
